STATE OF THE WATERSHED

Annual Newsletter of the Big Dry Creek Watershed Association

BIG DRY CREEK December 2016

Big Dry Creek 2015 Water Quality and Biological Monitoring Review

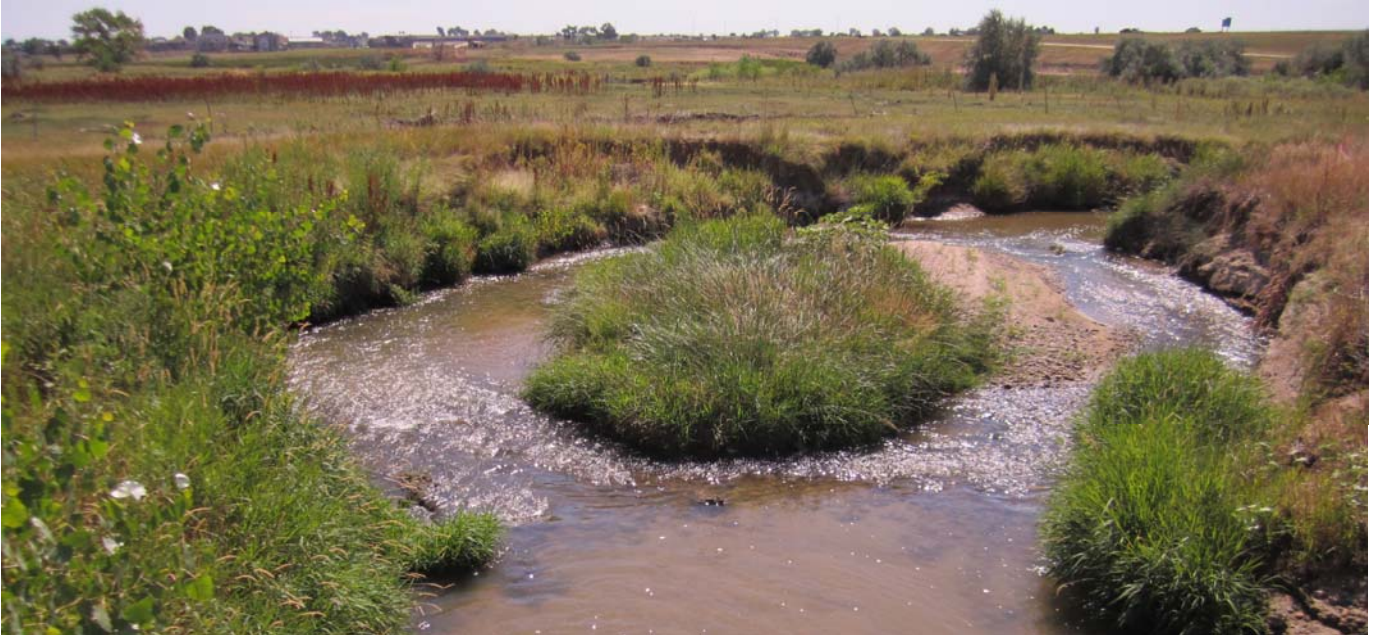
Channel evolution in the agricultural area of Big Dry Creek.

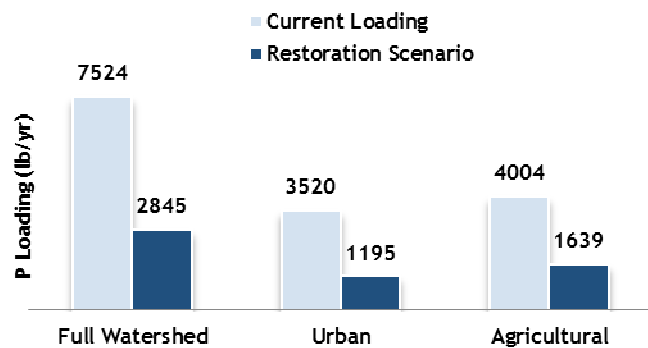
Figure 2. Phosphorus loading rates from bank erosion for the full watershed, urban portion, and agricultural portion under current conditions and a simulated restoration scenario.

CSU researchers also calculated the impacts of bank stabilization targeted to the areas with maximum erosion. Restoring ~30% of the eroding bank length (~3.6 miles) reduced loading rates from bank erosion by ~60% (Figure 2). This high nutrient load reduction is predicted because researchers assumed stabilization would occur on the banks with the greatest erosion. If stabilization was applied more randomly, the associated nutrient reduction benefit would be less. There is a certain amount of uncertainty associated with these results. First, the satellite imagery analysis only takes into account lateral channel adjustment; channel incision, or erosion of the bed, is not accounted for which could underestimate nutrient loading. Conversely, there is also no accounting for deposition and storage of eroded bank sediment, which could reduce the total load that ends up influencing water quality. Furthermore, the restoration scenario assumes bank stabilization completely eliminates bank erosion which may not be realistic.

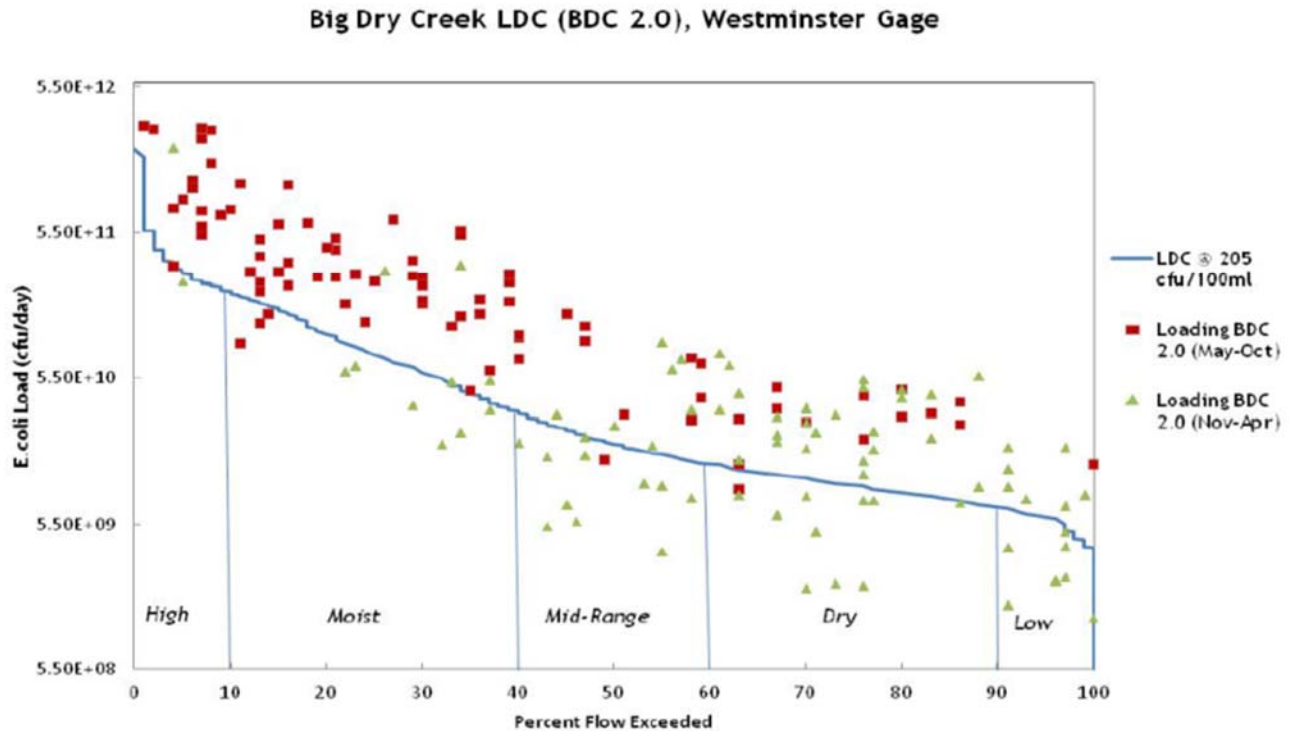
Figure 6.2-1 *E. coli* data (2003-2014) for bdc2.0 plotted on load duration curve based on Westminster flow gage.

loads for *E. coli* were developed for varying flow conditions at a representative assessment location in each reach. For purposes of the TMDL, allowable *E. coli* loading to Big Dry Creek was allocated among municipal WWTFs, municipal stormwater runoff (MS4s), non-point sources (e.g., agriculture), a reserve capacity to allow for urban development, and a margin of safety (MOS). Table 3 from the TMDL provides an example of the loading and load reduction targeted for the middle reach of Big Dry Creek, which is located in the general vicinity of the open space behind Front Range Community College to 152nd Avenue. The existing *E. coli* conditions for various flow regimes are illustrated on a Load Duration Curve for the segment as shown in Figure 6.2-1 from the TMDL. Values above the blue line exceed the allowable loading for the stream.
