Erosion Potential and Water Quality Impacts: Big Dry Creek, CO

Final Report

Roderick W. Lammers
Colorado State University

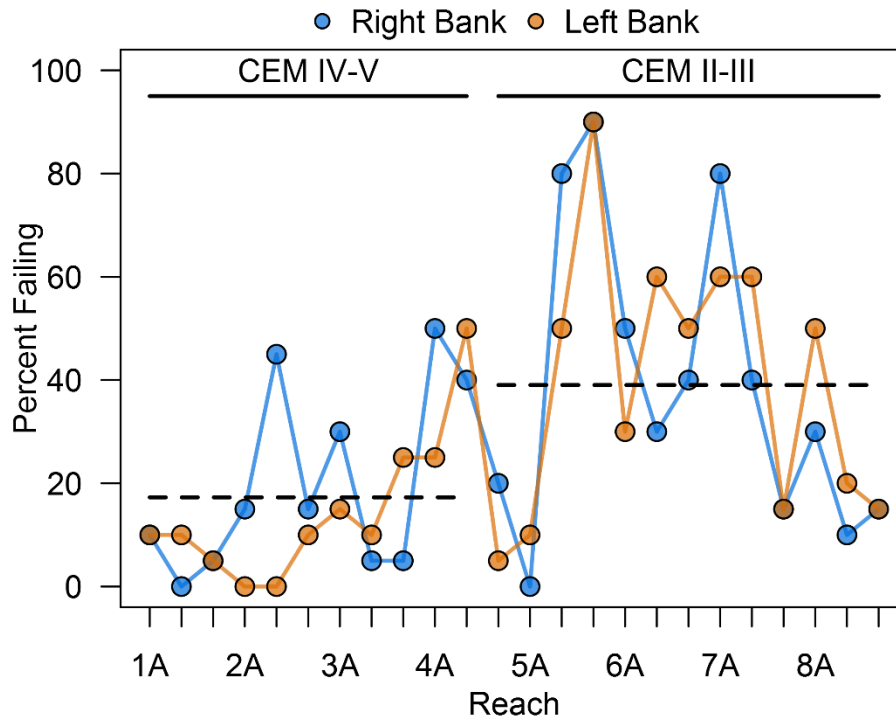
Figure 2. Field estimates of the percentage of right and left banks failing for each site. The upstream section (Reach 1A – 4B) was in CEM stage IV-V (stabilizing) while the downstream section (Reach 4C – 8C) was in CEM stage II-III (incising and widening). Horizontal dashed lines are the mean percent of banks failing for each group.

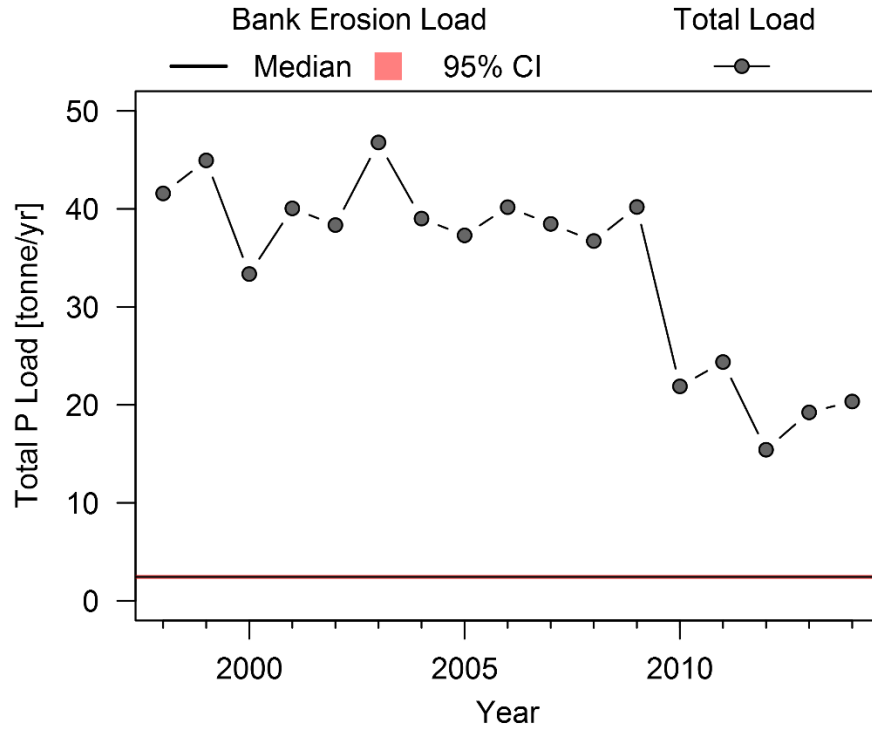
Figure 4. Calculated total phosphorus load (metric tonnes / year) from bank erosion (with shaded 95% confidence interval) compared to the total annual phosphorus load measured at the outlet of Big Dry Creek. Note the 95% CI is very narrow and may be difficult to see.

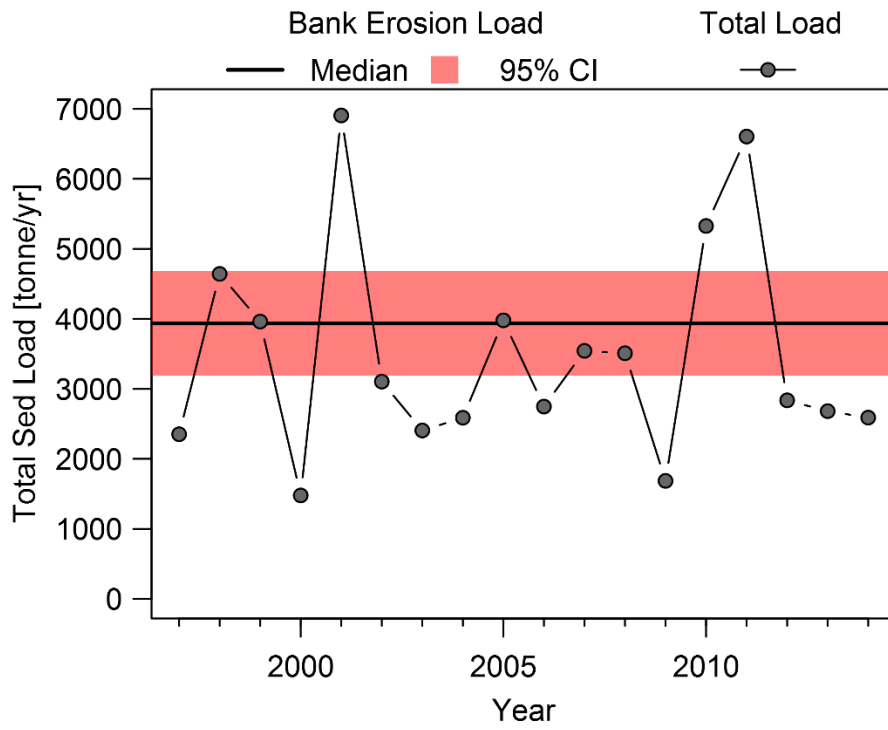
Figure 5. Calculated total suspended sediment load (metric tonnes / year) from bank erosion (with shaded 95% confidence interval) compared to the total annual suspended sediment load measured at the outlet of Big Dry Creek.

While bank erosion is not the primary source of phosphorus loading to Big Dry Creek, it is a major contributor of suspended sediment. Based on long-term monitoring by the Big Dry Creek Watershed Association, the primary source of phosphorus loading is municipal wastewater treatment plant discharges, although recent plant upgrades have significantly reduced phosphorus loading (see the significant drop in total phosphorus loading post 2009 in Figure 4). This drop in the total watershed phosphorus load means a larger percentage of this load may be attributed to bank erosion. Bank stabilization can reduce both phosphorus and sediment inputs to the stream, but will be insufficient for addressing phosphorus pollution without reducing loading from other sources.

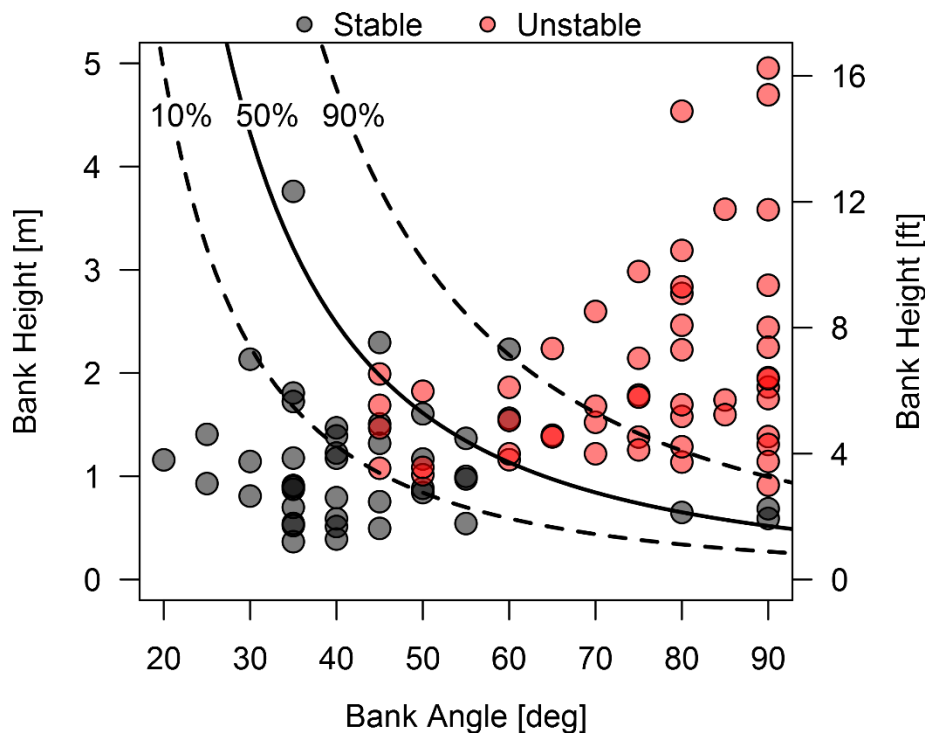
Figure 6. Field collected data on bank height and angle for stable and unstable banks. Lines show probabilities of failure predicted from the logistic regression equation.

Figure 6 shows bank heights and angles from stable and unstable banks. Curves are the fitted logistic regression model ($\beta_o = 27.1$, $\beta_\alpha = -6.5$, $\beta_H = -3.4$) for different failure probabilities. There is some overlap between unstable and stable banks which suggests that our assumption of consistent bank strength was not entirely accurate. This uncertainty, however, is incorporated within the logistic regression model (i.e. the distance between the 10% and 90% lines).

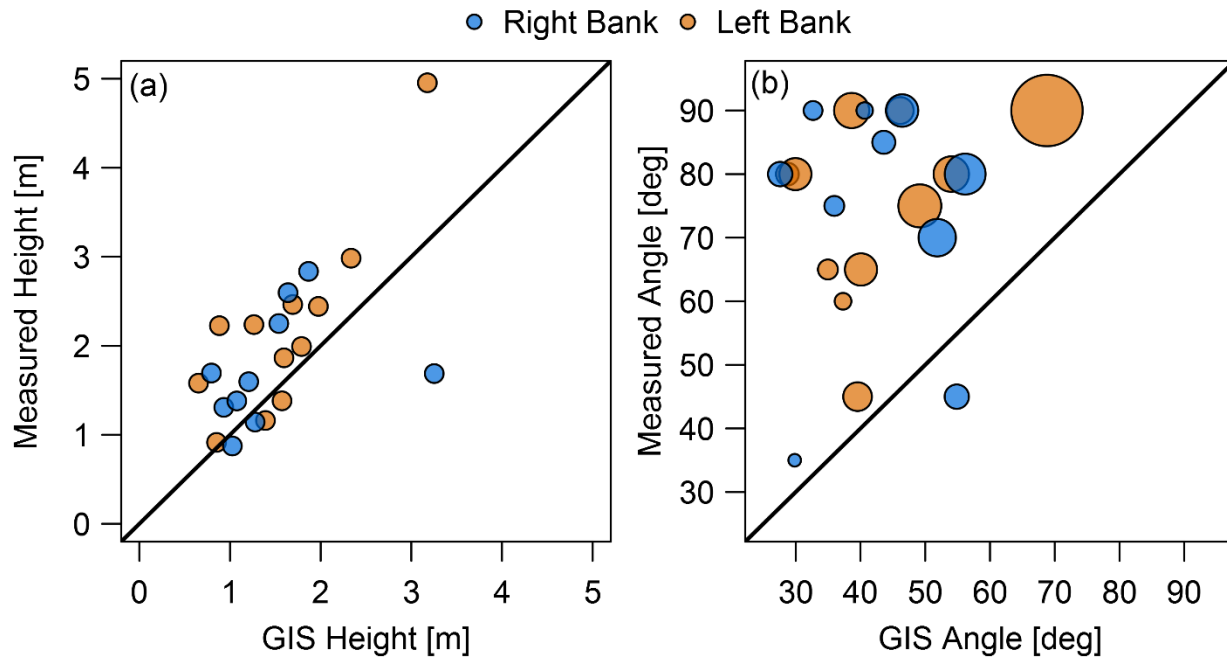
Figure 7. Field measured heights (a) and angles (b) versus values obtained from the high resolution DEM. Dots are colored based on location (right or left bank). Points in the angle plot (b) are sized according to bank height (e.g. larger points for taller banks).

Figure 7 compares our field measured bank heights and angles with those obtained from the GIS analysis. Our GIS approach did a relatively good job of predicting bank heights but it consistently under-predicted bank angles. While the DEM is relatively high resolution (0.75 x 0.75 m), it still is insufficient to capture very steep (>70 degree) slopes, especially on relatively short banks. The points in Figure 7b are sized relative to bank height (large = taller banks). Bank angles were somewhat more accurate for the taller banks where elevation and slope differences were better captured by the DEM.

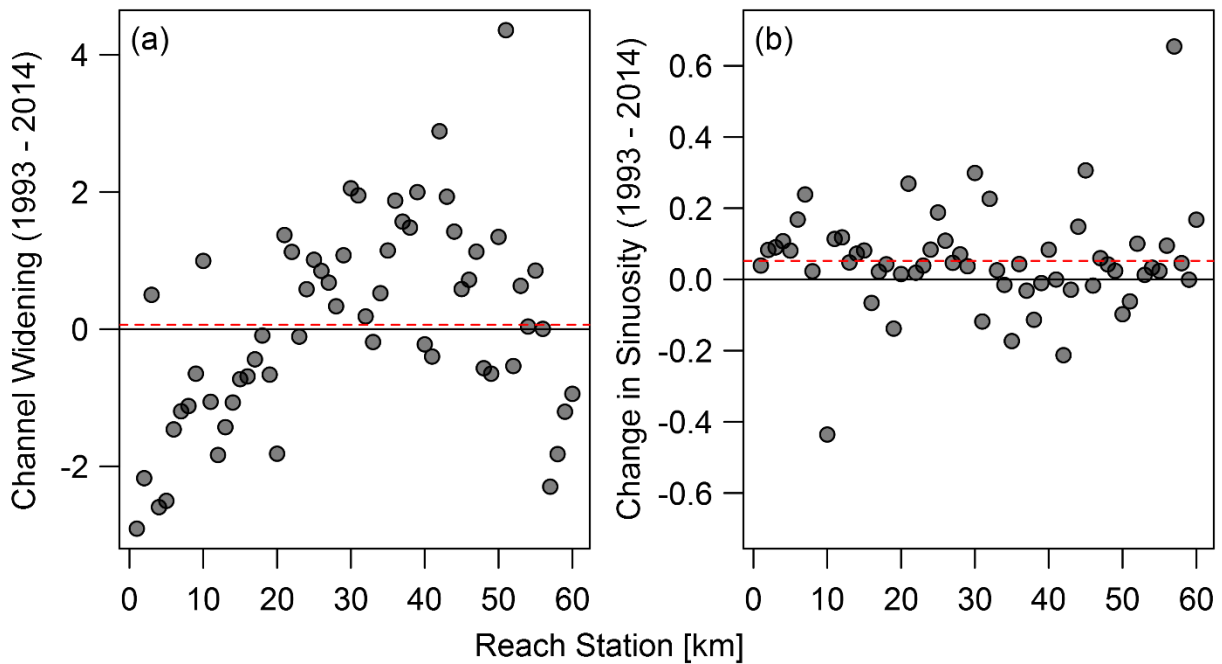
Figure 9. Changes in channel width (a) and sinuosity (b) from 1993 – 2014 for the same 60, ~1 km reaches. Dashed red lines are mean values.

Despite the relative stability of the channel bed, Big Dry Creek is still laterally unstable and is prone to meander bend migration. This is supported by a measured increase in sinuosity from 1993 – 2014 (Figure 9) and the fact that most unstable banks are located on the outside of bends (e.g. Figure 8). This lateral migration is relatively consistent throughout the watershed; however, bank heights are generally higher in the upper watershed because this area has experienced more incision. These banks are more susceptible to failure and will contribute larger volumes of sediment and phosphorus to the channel than the smaller banks in the lower watershed.

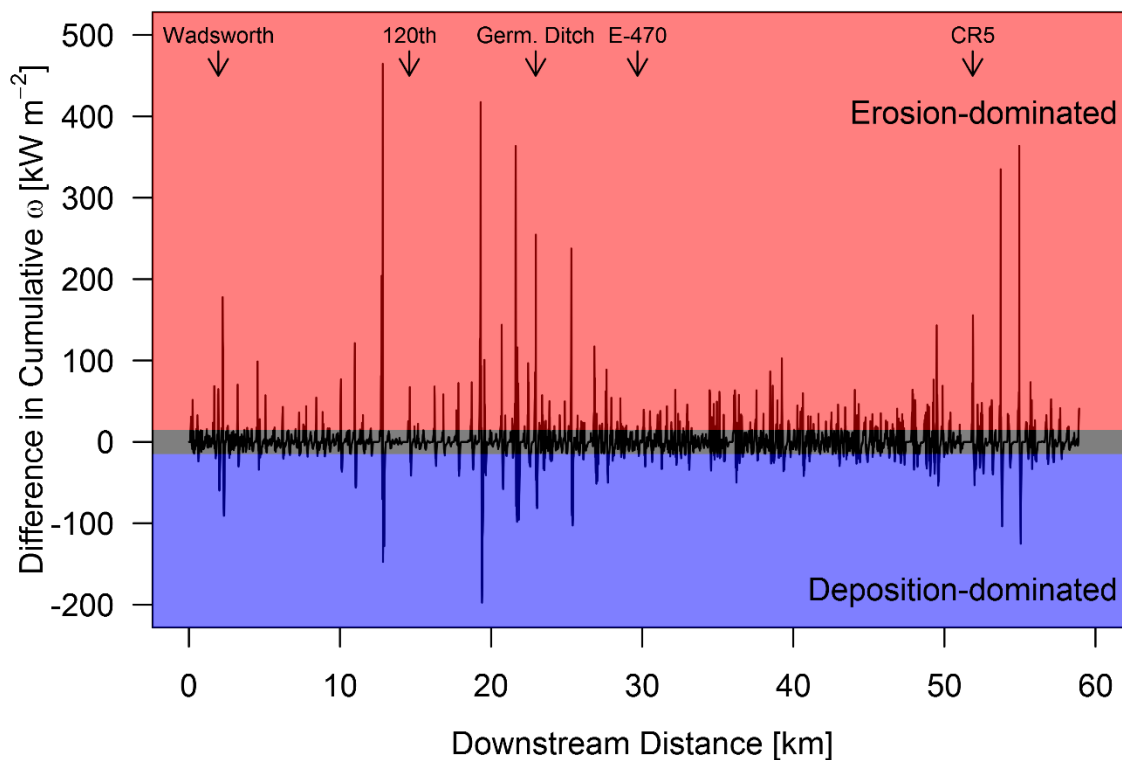
Figure 10. Difference in cumulative stream power versus downstream distance. Gray shaded band is $\pm 15 \text{ kW/m}^2$, an approximate threshold for transport-dominated reaches. Locations of various road crossings and one diversion are identified by arrows.

Maps 4a-b show differences in cumulative stream power along Big Dry Creek. There is a mix of deposition- and erosion-dominated sections, but the majority of the channel is classified as “transport” (i.e. no net erosion or deposition). There are no apparent trends in erosion or deposition potential. Most erosion-dominated points appear to be balanced by an adjacent depositional area (and vice versa). This can also be seen by plotting stream power difference by downstream distance (Figure 10). This suggests qualitatively that local erosion in Big Dry Creek is relatively balanced by local deposition. Quantitatively, however, we can see that the magnitude of the erosion areas (positive values) are much larger than the magnitude of depositional areas (negative values). In fact, the sum of the stream power difference values along Big Dry Creek is ~230 kW/m which indicates that there is significant excess power in the stream and it is overall erosional.

Many of these erosion-deposition sequences are located at bridge crossings, diversions, or grade control structures. For example, the largest peak, just upstream from 120th Ave, is a grade control structure co-located with the upstream USGS gage. These areas tend to be artificially armored to prevent significant erosion so many of the erosional and depositional areas identified in this analysis may be in parts of the channel that are less inherently prone to change. There are other areas, however, which may not be armored and are therefore susceptible to erosion. Figure 11 is a zoomed-in view of a single reach showing the results of the stream power difference analysis. The sequence of erosion, deposition, and transport-dominated reaches can be clearly seen moving downstream.

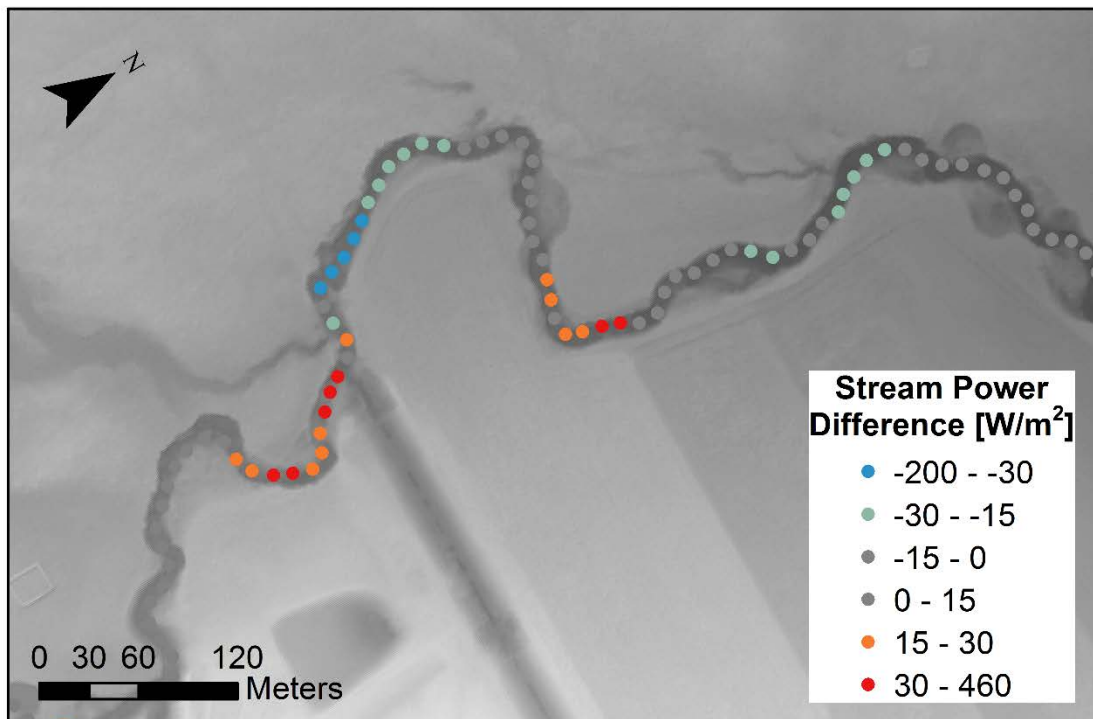
Figure 11. Example map of the stream power difference analysis. Red and orange regions are erosion-dominated, blue and green are deposition-dominated, and gray are transport-dominated. High resolution DEM shown in background. Flow direction is left to right.

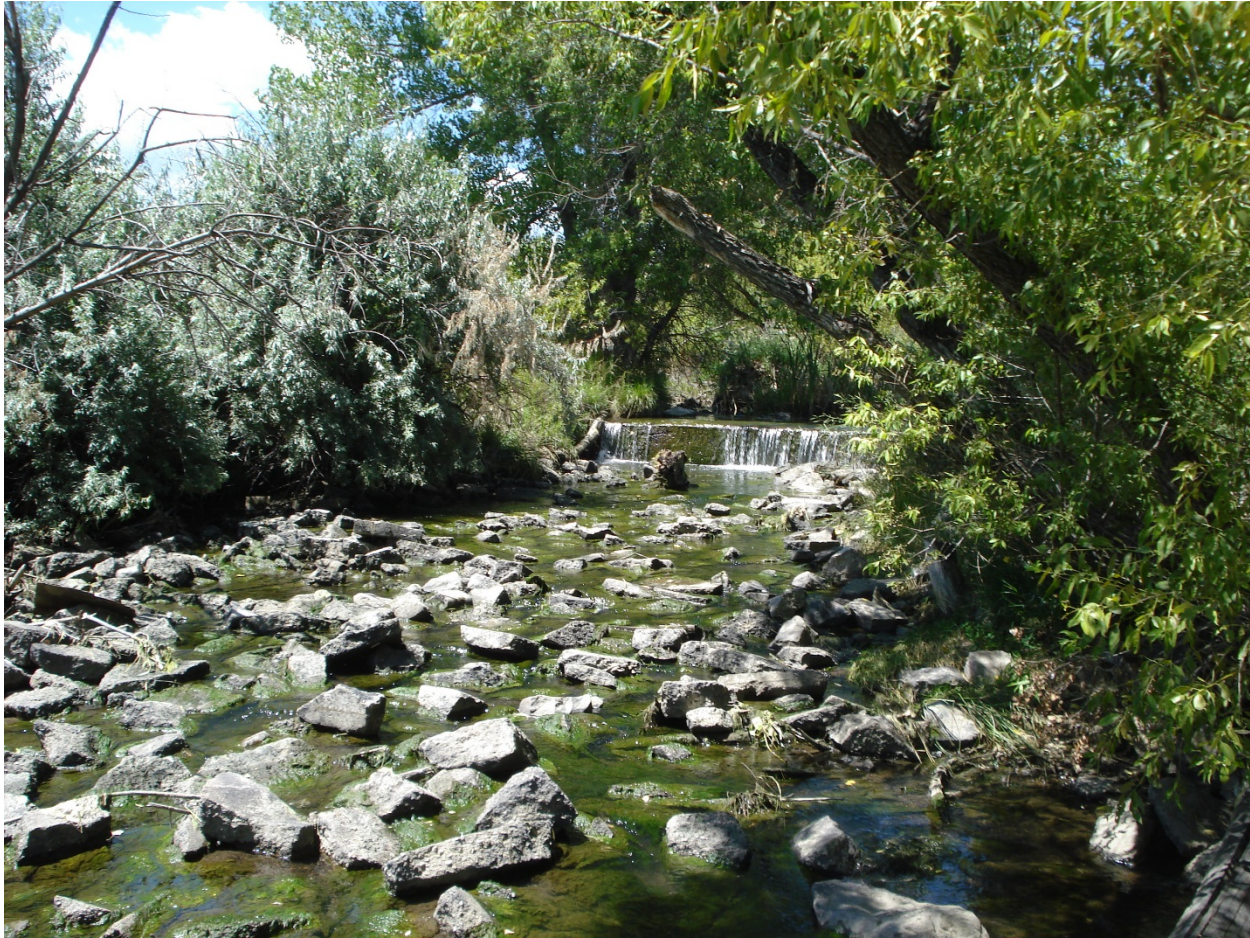
Photo 1, Reach 1C: Looking upstream at a grade control structure in the upper part of Big Dry Creek. Note significant amount of rip-rap downstream from structure stabilizing the bed. This substrate also provides structure for filamentous algae growth.

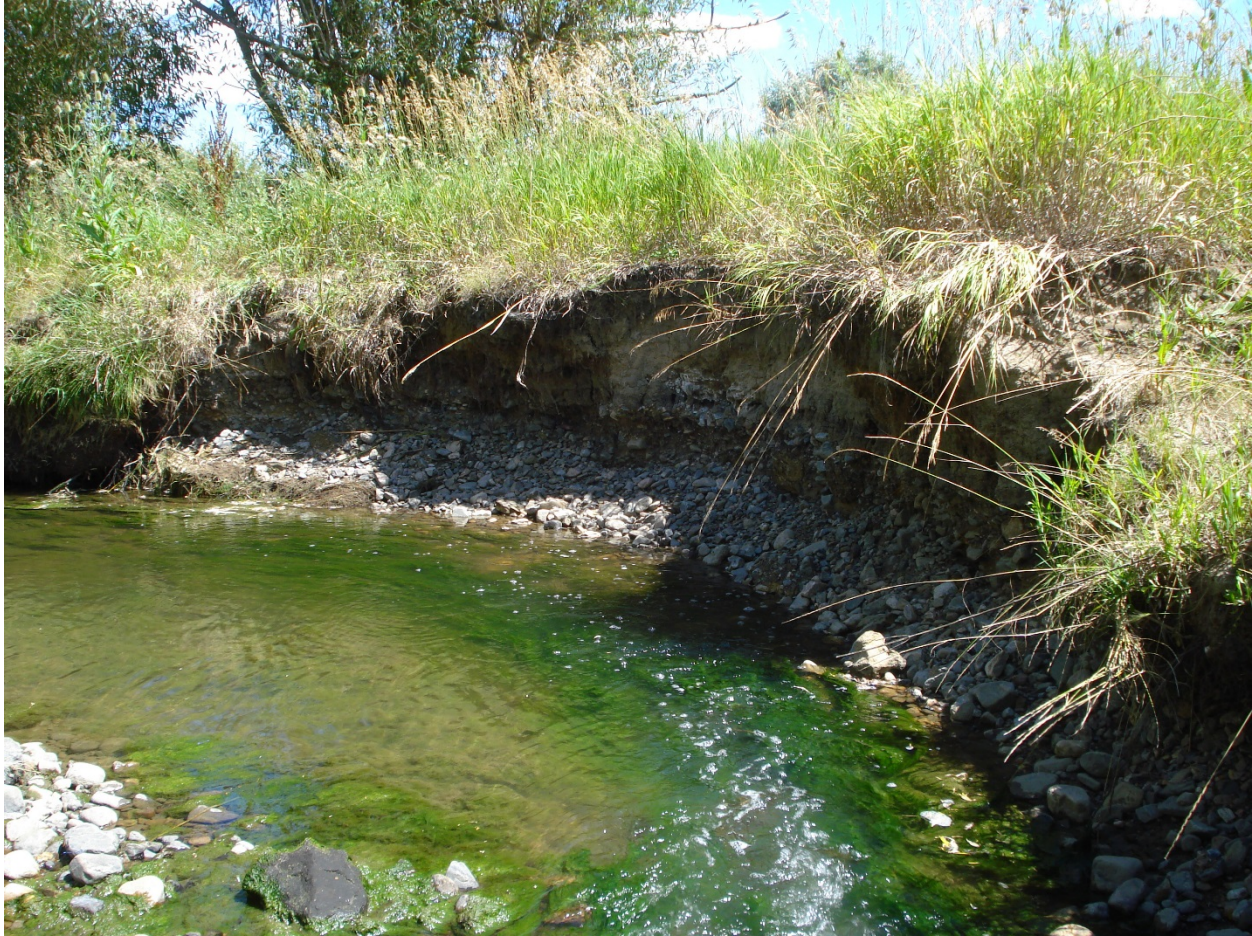
Photo 2, Reach 2A: An eroding bank on the outside of a meander bend. In this section of Big Dry Creek, there is still significant coarser bed material. This coarse material makes up the majority of the bank toe while the upper bank is all sandy clay. View looking downstream.

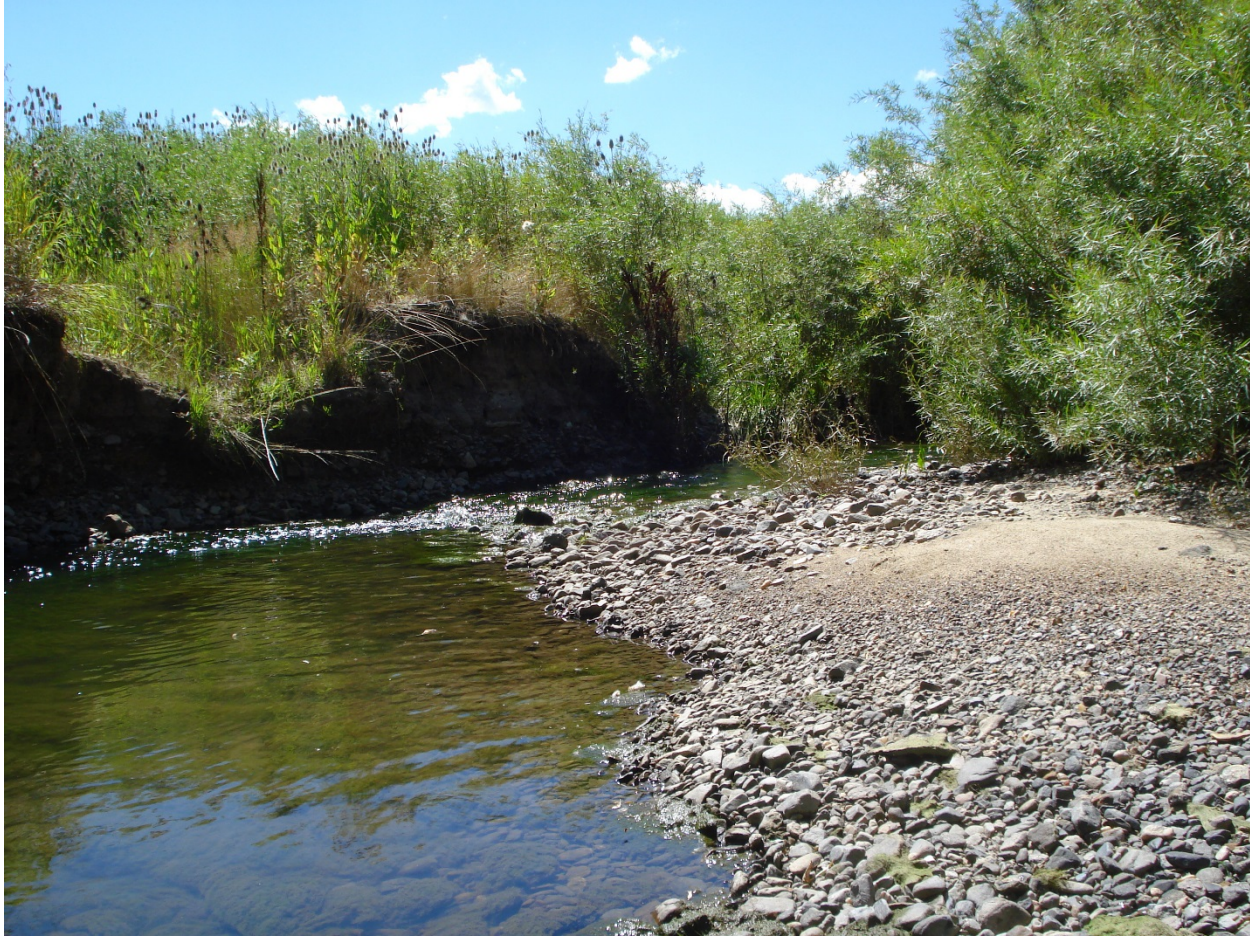
Photo 3, Reach 2A: While there is evidence of bank erosion, the channel bed is relatively stable and even shows evidence of significant deposition (large bar on the right of the photo with coarse gravel/cobble and a finer sand patch). View looking upstream.

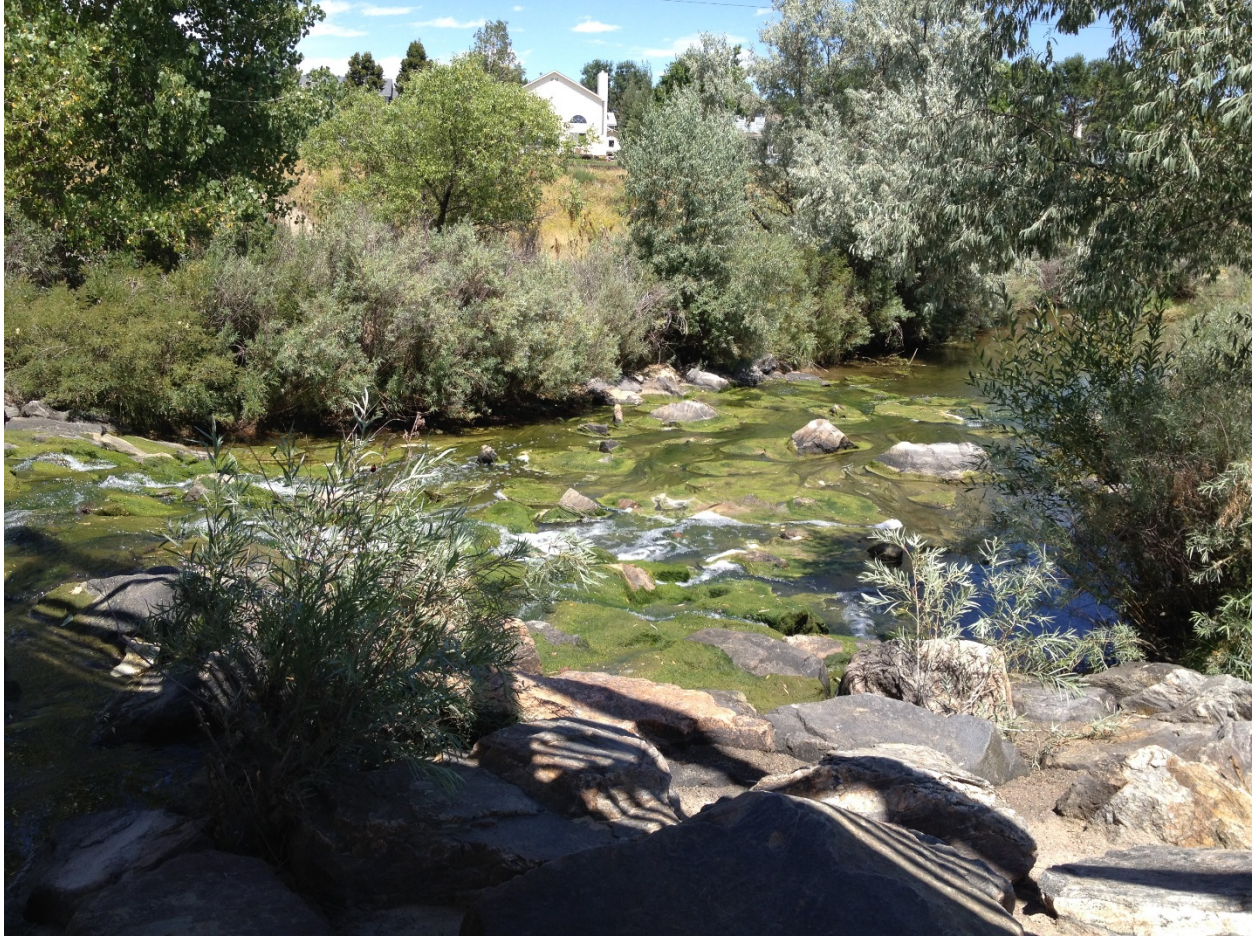
Photo 4, Reach 3B: View downstream of a large grade control structure stabilizes the channel bed in a park. Filamentous algae were abundant during the August field campaign, which was conducted during relatively low flow conditions.

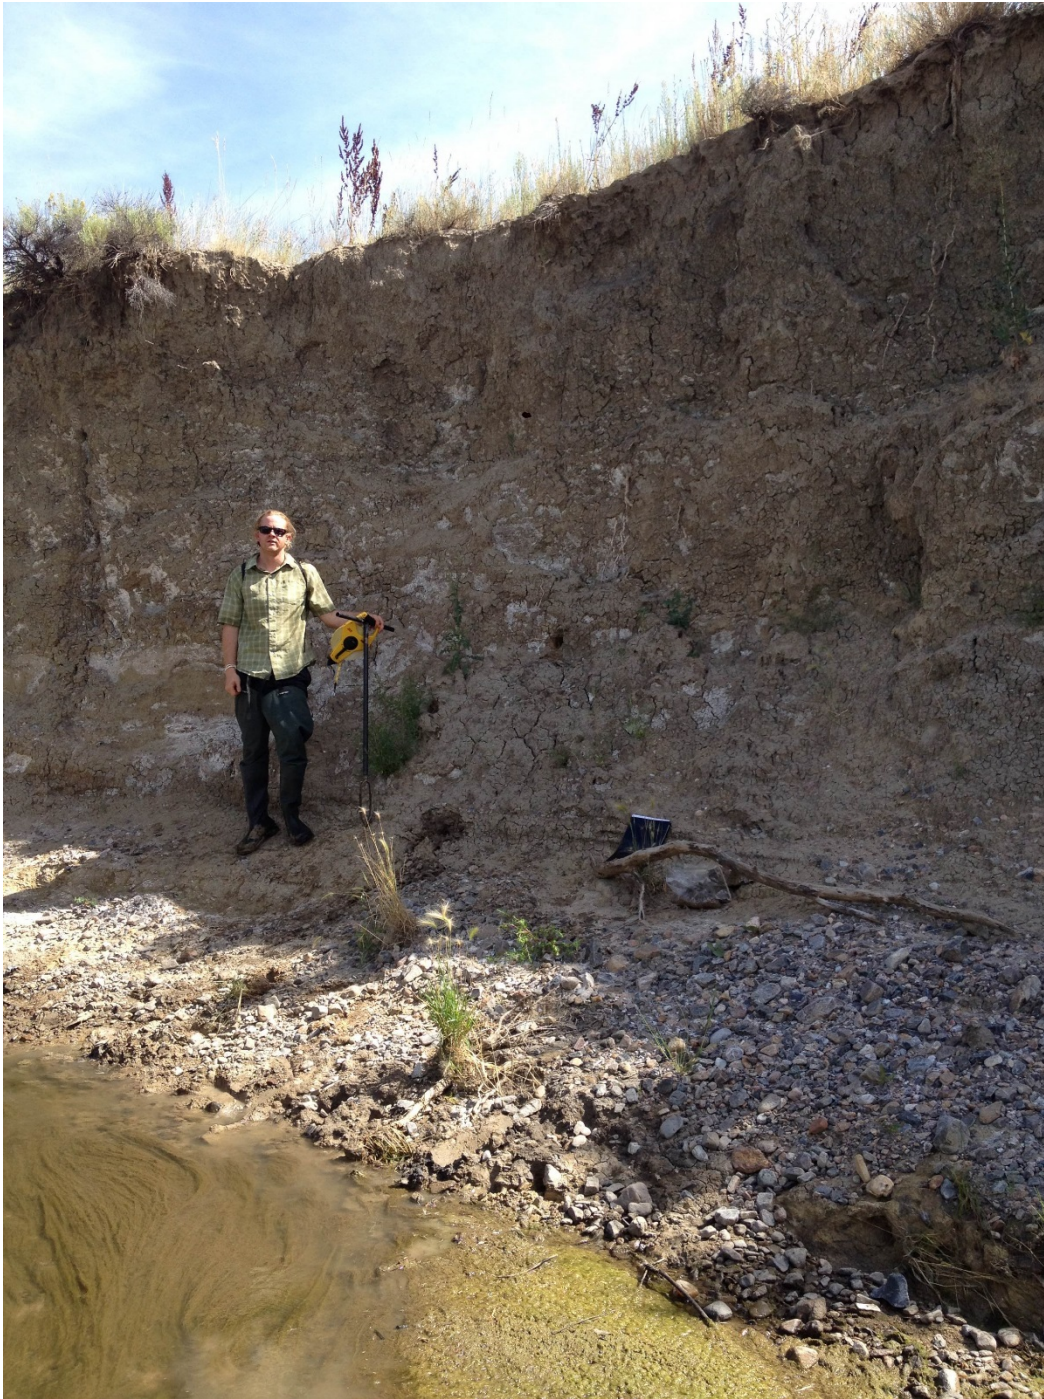
Map 1 shows the locations of the field sites, colored by reach. Example photographs from all reaches are attached to this report. Changes in channel form and erosion magnitude can be clearly seen moving downstream. In general, the upper reaches (1 – 4) are more vertically stable, although there is still significant bank erosion, especially on the outside of meander bends. The upper three reaches have substantial gravel and coarser material on their beds. By reach 4, the channel bed is nearly entirely sand with isolated areas of exposed clay. The field reconnaissance suggests that the percentage of failing banks increases moving downstream (Figure 2). These observations also indicate that the upper reaches of the stream are generally in the later stages of the CEM (Stage IV-V), as evidenced by sediment deposition within in the channel and the formation of inset floodplains in some areas. The lower reaches (5 – 8) are generally in the earlier stages of the CEM (Stage II-III) – although these reaches might be classified as in a state of “arrested incision”. Here, the channel has incised and there has been some widening and bank erosion; however, natural and artificial grade controls appear to be limiting further incision. This may prevent widespread bank instability and significant widening. The larger percentage of bank failures in these lower reaches is primarily from smaller, more frequent failures rather than the tall, eroding cutbanks observed in some of the upper reaches (see, for example, Photos 5, 6, and 8).

Photo 5, Reach 3C: A tall, nearly vertical cutbank (~ 4.5 m or 15 ft). Sparse vegetation is doing little to stabilize this bank. Flow direction is left to right.

- **Bank stabilization/revegetation:** The GIS bank stability analysis (Maps 2 – 3) identified unstable banks. These data can be used to locate high-priority restoration areas (e.g. unstable sections near trails, roads, or other infrastructure) which may benefit from bank stabilization. Stabilization may entail grading banks to gentler slopes but should incorporate toe protection to avoid bank undercutting and failure. Additionally revegetation and other bioengineering techniques should be considered. The effectiveness of vegetation in preventing bank erosion was clearly seen during the field campaign (compare vegetated banks, photos 7 and 9, with unvegetated banks, photos 5, 6, and 8).

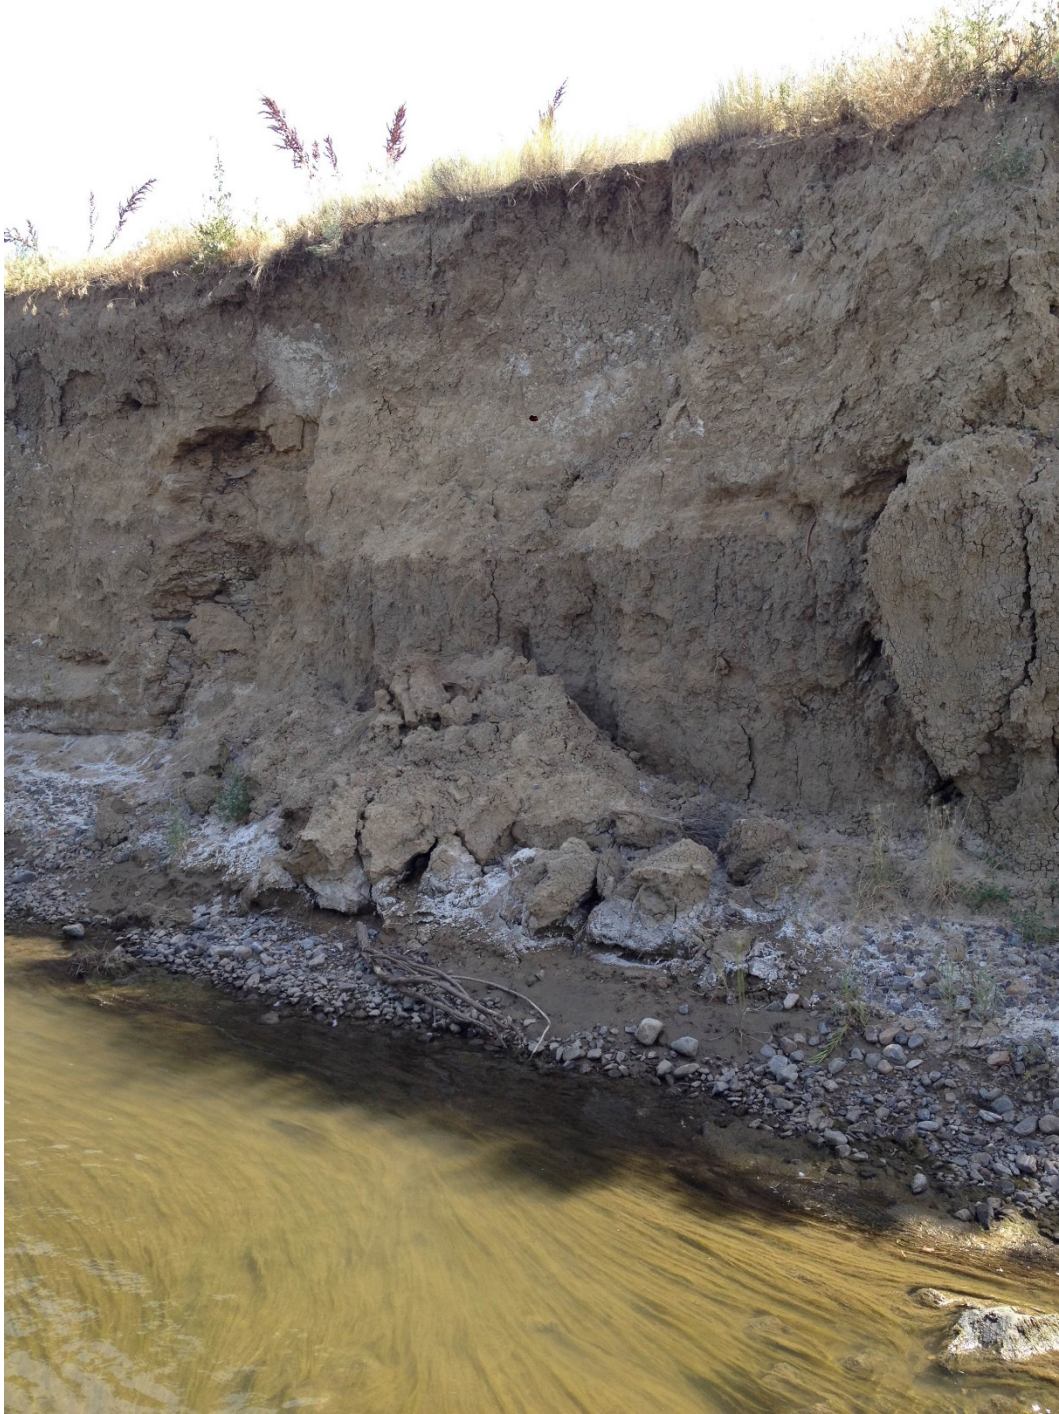
Photo 6, Reach 3C: A recent bank failure. Wetting-drying cycles appear to be weakening the bank material, making it more susceptible to fluvial erosion and mass failure. Flow direction is right to left.

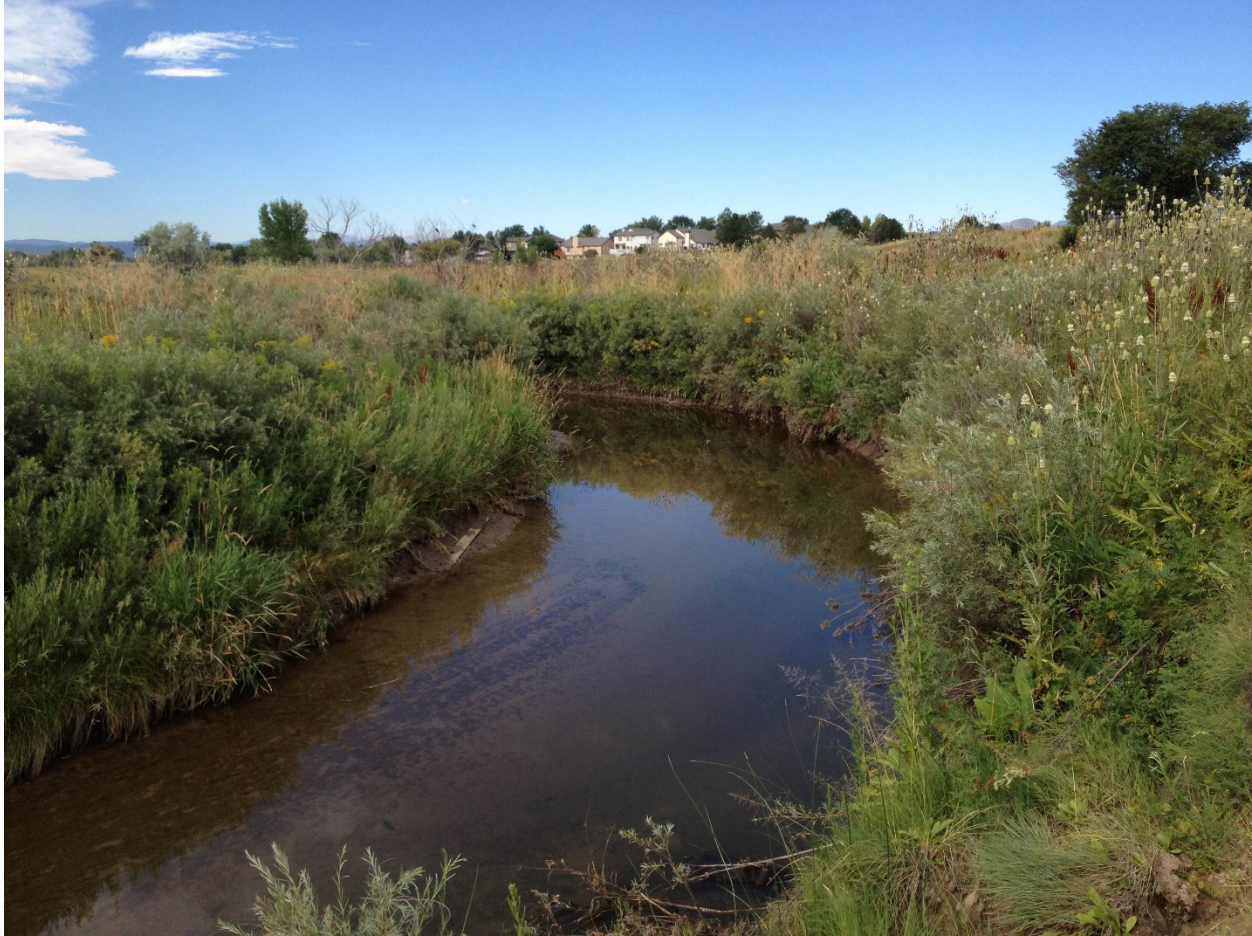
Photo 7, Reach 4A: The outer bank of a meander bend stabilized by dense vegetation. View looking upstream.

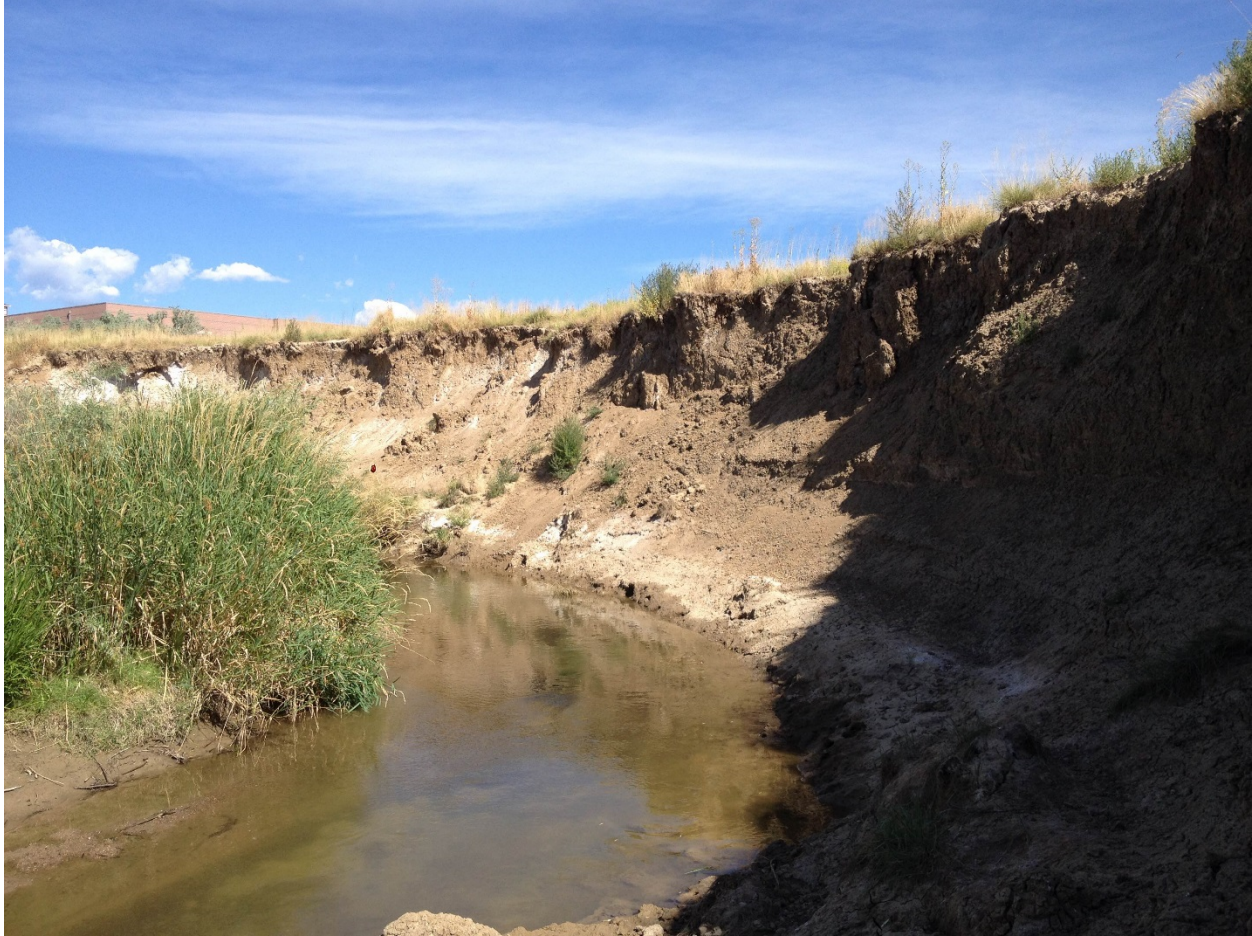
Photo 8, Reach 4B: An unstable outer bank of a meander bend with no vegetation. View looking upstream.

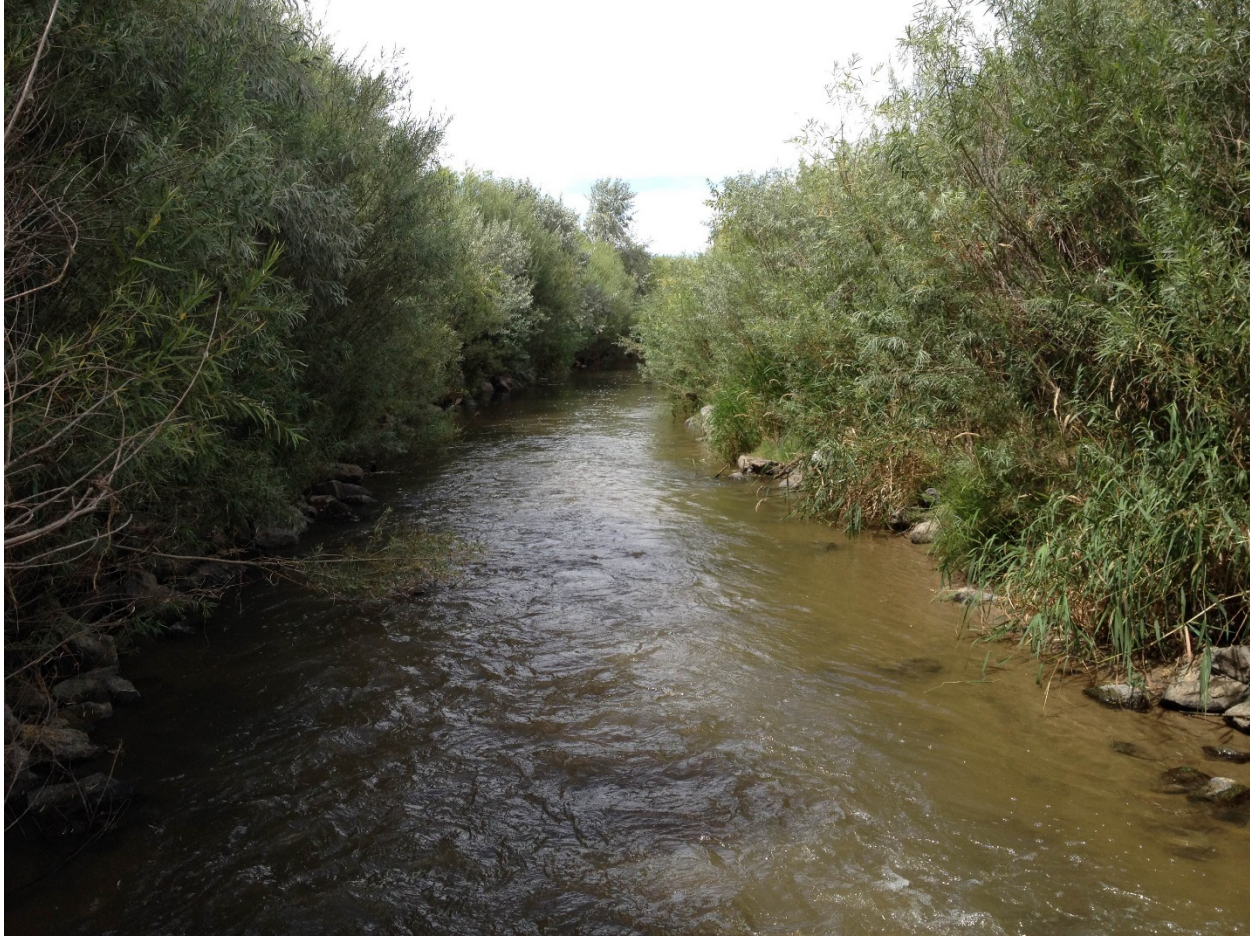
Photo 9, Reach 5A: This reach appears to have been stabilized with rip-rap along the bank toes and possible willow plantings. The channel bed in this section is primarily stiff clay which may slow further incision. The lack of alluvium also suggests this reach has an excess of transport capacity. View looking downstream.

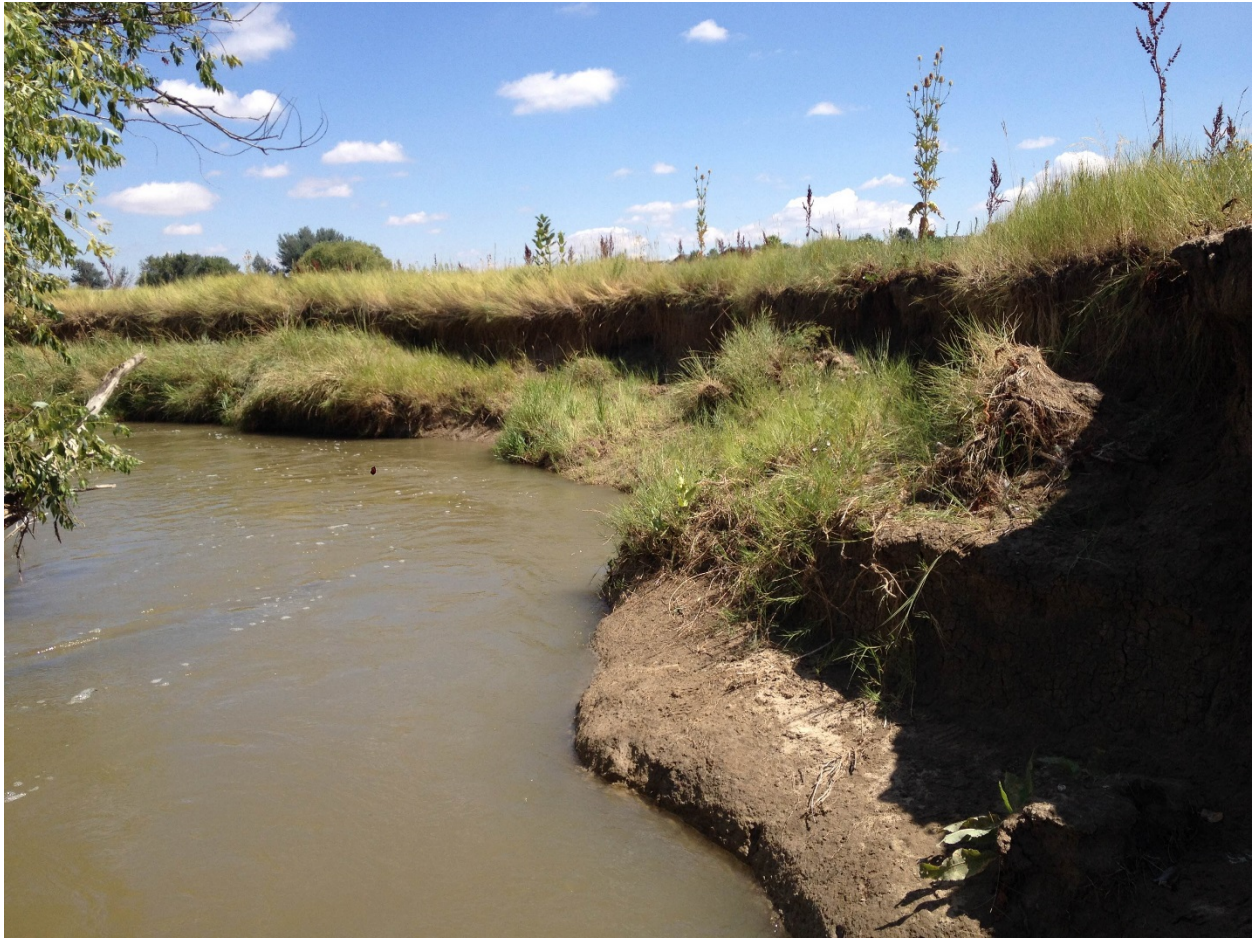
Photo 10, Reach 6A: Failed blocks of bank material temporarily protect the bank from further erosion. View looking downstream.

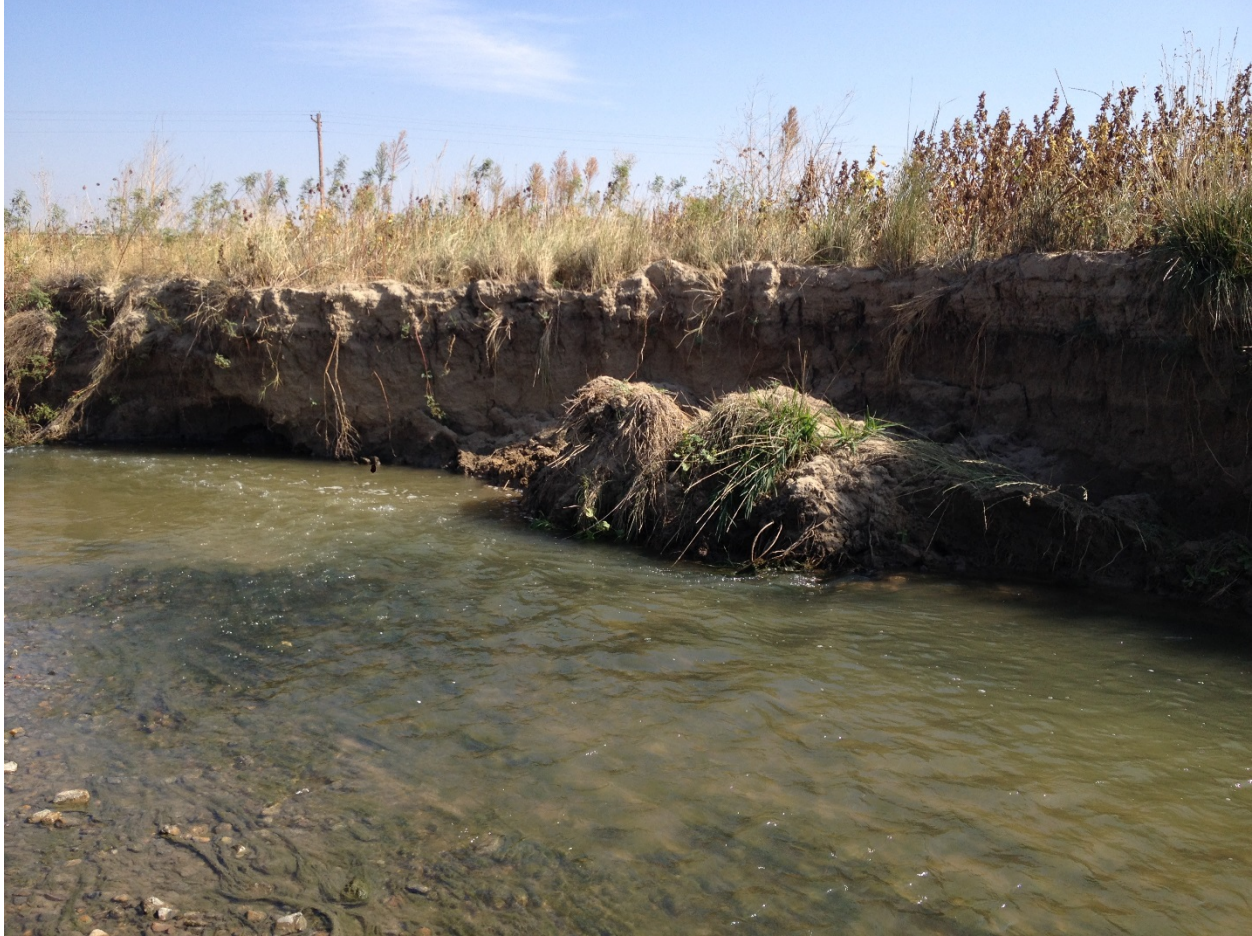
Photo 11, Reach 7A: A sandy, unstable bank with failed bank material. Banks in the lower reaches are generally shorter than in the upper watershed. View looking downstream.
