Erosion Potential and Water Quality Impacts: Big Dry Creek, CO

Final Report

Roderick W. Lammers
Colorado State University

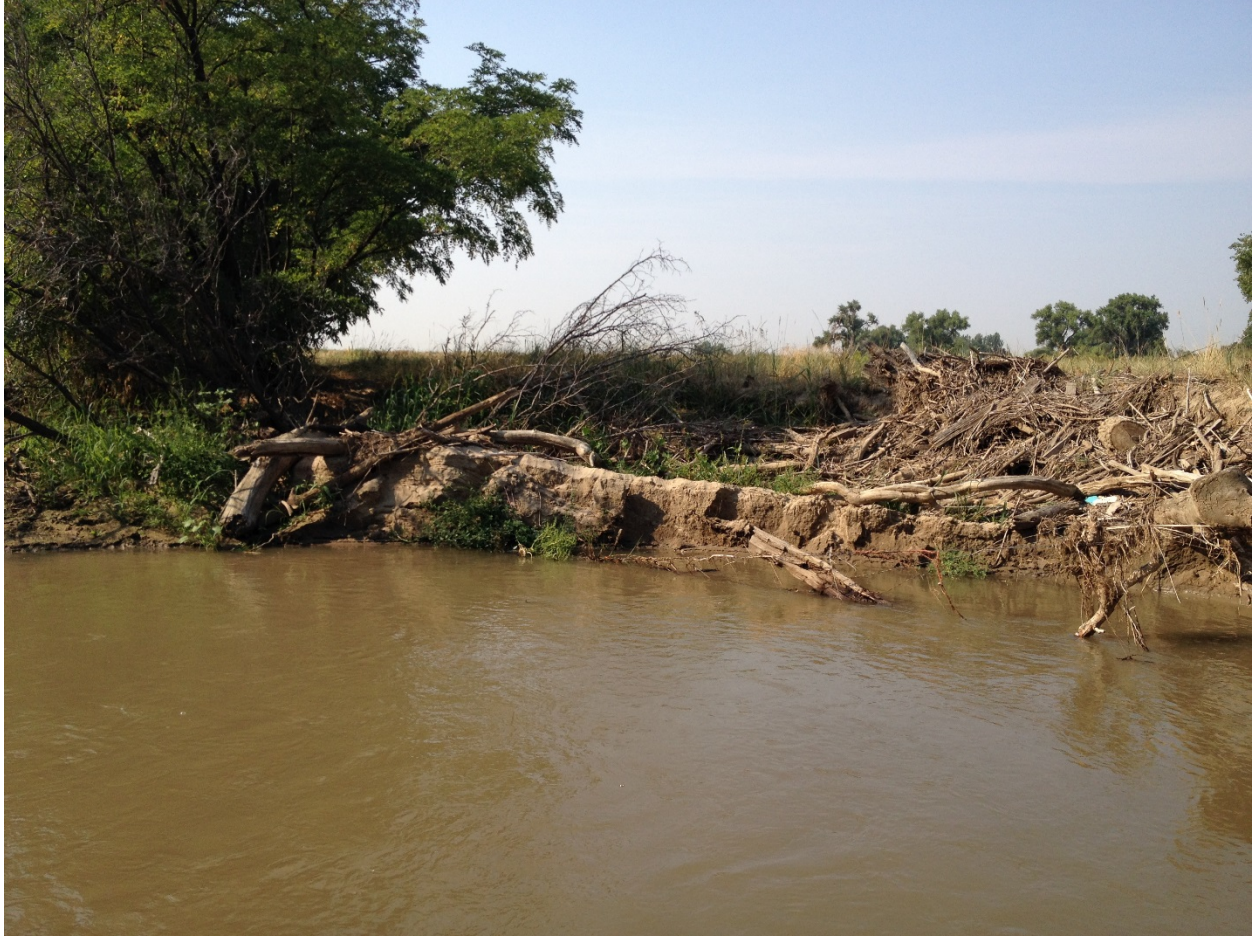
Photo 12, Reach 8B: Evidence of deposition in the lower reaches of Big Dry Creek. In general, this lower section had much more sand than areas further upstream. Flow direction is left to right.
